**George Town Harbour – Repair of an Existing Seawall
Block: OPY Parcel: 18**

June 15, 2021

Authored by: Technical Review Committee - Department of Environment, on behalf of the Director,
Department of Environment

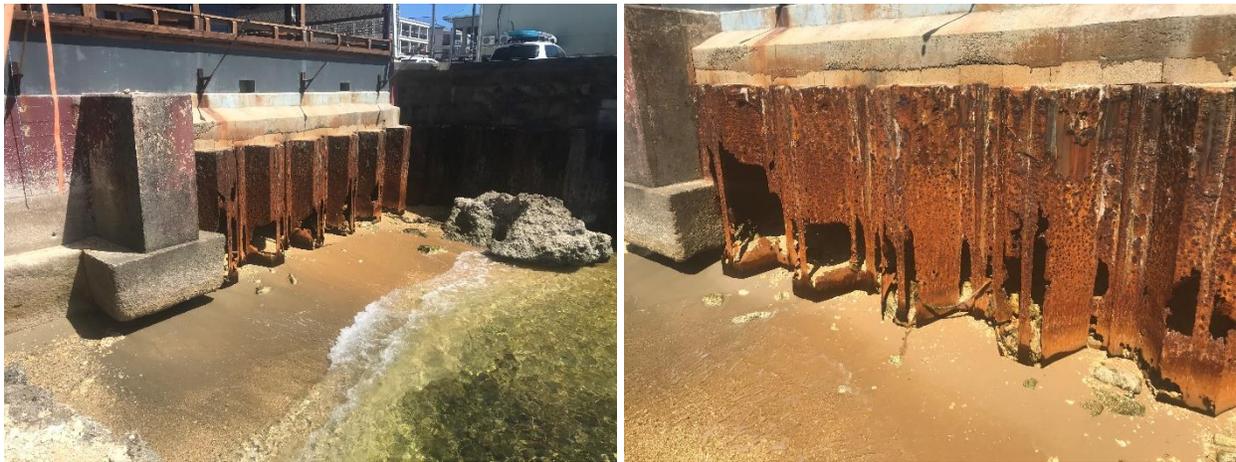
The applicant-Little Liquor Store Ltd.- is seeking permission for the repair of an existing seawall in order to secure the existing structure that is being undermined by corrosion and impact from the sea, as shown in Figures 1 and 2.

FIGURE 1: DOE SITE VISIT PHOTOS SHOWING THE DAMAGED SEAWALL (2021)

- 1) All debris created by the wire brushing of the seawall shall be removed by vacuum for disposal offsite prior to placement of the seawall form work.

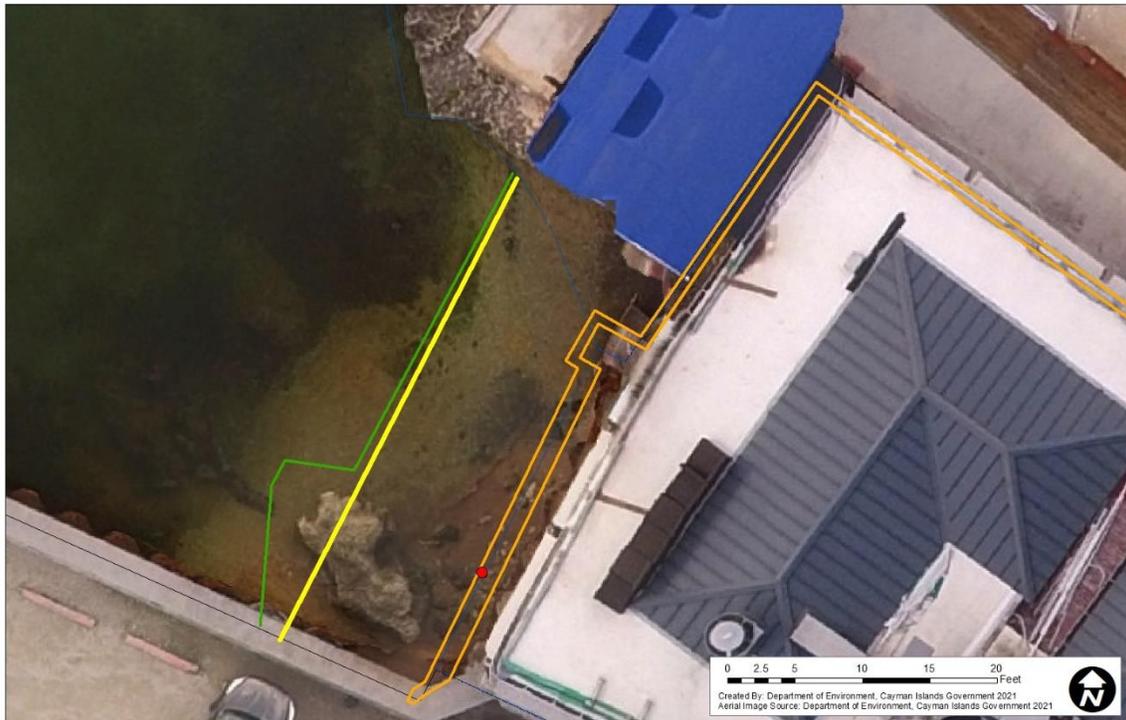
The proposed works will affect approximately 16.5 square feet of Crown property. The area of the works will be completely contained using both silt screens and a sand bag wall placed approximately 10ft seaward of the seawall (as shown in figure 2 below) to minimise wave action and to contain and turbidity created by the works. Initially a trial excavation will be carried out in a small area in the footprint of the seawall in order to establish the depth to bedrock as shown in red in figure 2 below. A small excavator will be lowered into position in front of the seawall from the neighbouring parcel seawall area to the south in order to conduct the excavation by removing 2 cubic yards of sand from the seabed. Once those works are completed the excavator will be removed. Following this, the corrosion covering the existing seawall will be removed by hand using wire brushes and any resultant debris will be cleaned from the area by vacuum. Once the formwork for the seawall has been prepared, the small excavator will once again be lowered into position to carry out the remaining excavation for the footing of the seawall. The formwork will then put in place and the concrete for the seawall poured. Any sand excavated during the works is to be returned, and all construction debris, seawall formwork and sand bags shall be removed from the area immediately following the completion of the works.

FIGURE 2: AERIAL IMAGERY SHOWING THE PROPOSED SEAWALL (ORANGE), THE TRIAL EXCAVATION AREA (RED), THE SILT SCREEN PLACEMENT LOCATION (GREEN) AND THE SAND BAG WALL (YELLOW) (SOURCE: DOE, 2021)

- 4) Turbidity resulting from construction shall be mitigated through the installation of silt screens and a sand bag wall placed approximately 10ft seaward of the seawall of sufficient length to fully enclose the work area. Work shall not commence without these in place. Screens must be maintained to the satisfaction of the DoE and remain in place throughout the construction until the water contained in the screen has cleared to the same appearance as the water immediately outside of the screen.

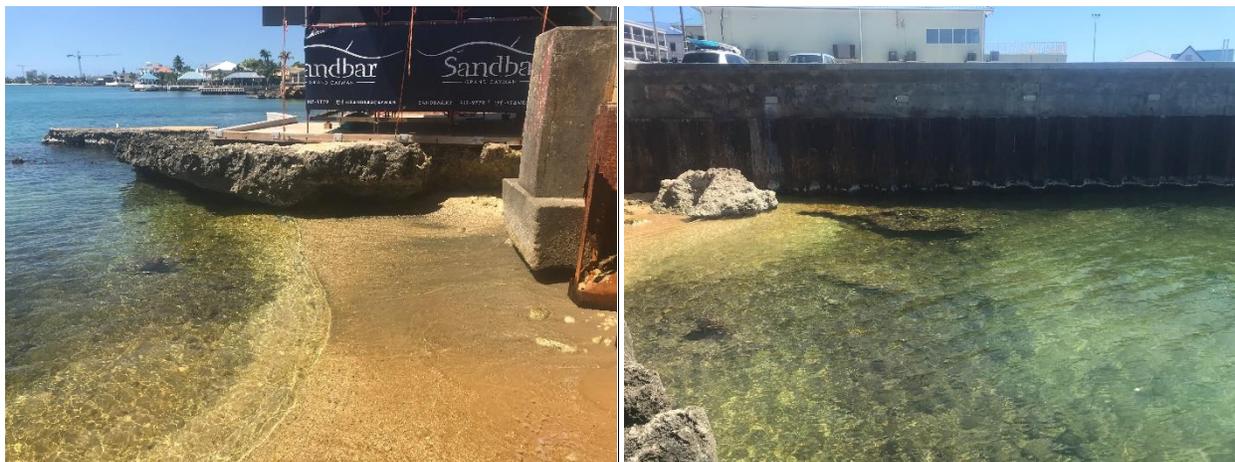
FIGURE 3: DOE SITE VISIT PHOTOS SHOWING THE AREA OF THE PROPOSED WORKS (2021)

The area of the proposed works is a Port Control Zone, having previously been a Marine Park prior to the establishment of the Cayman Islands Enhanced Marine Protected Areas. The immediate area of the proposed work is predominantly sand, loose rock and algae, as shown in figure 3 above. The wider surrounding marine environment

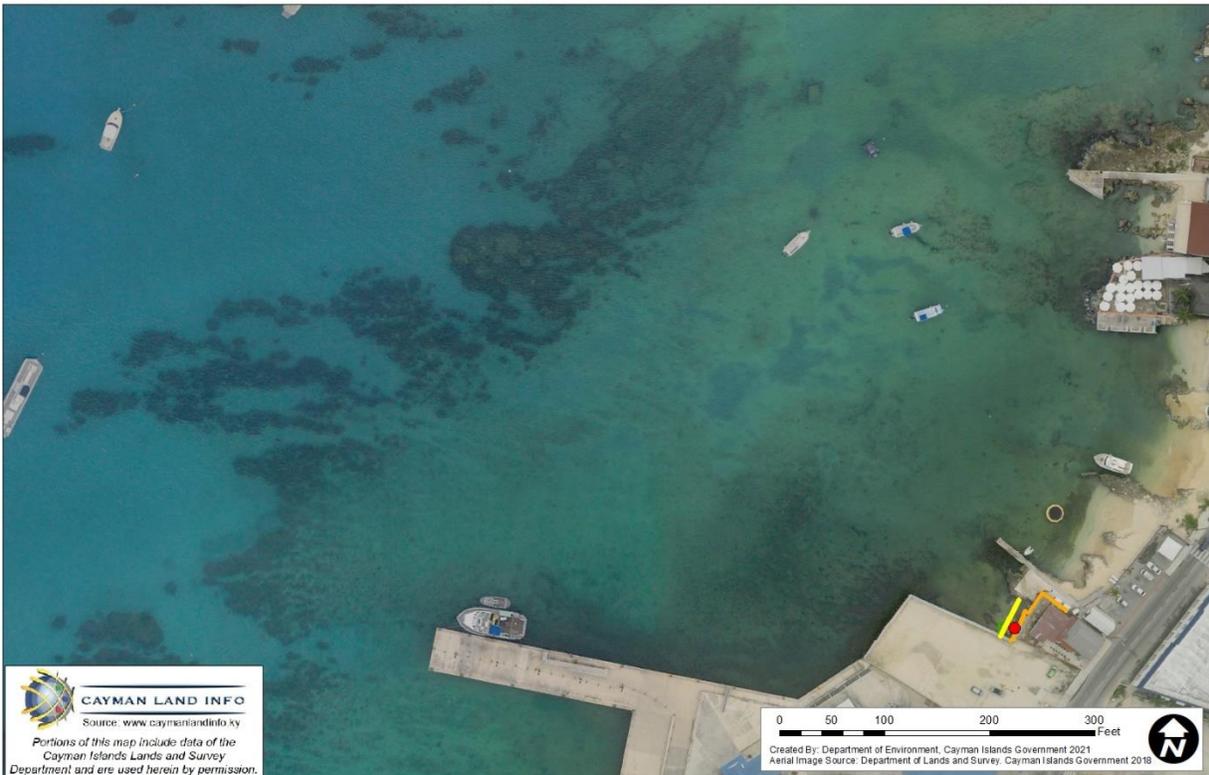
does include ecologically important coral reef habitat in the immediate vicinity of the proposal, as shown in figure 4 below, which is a potentially vulnerable receptor to the impacts of the works.

FIGURE 4: AERIAL IMAGERY SHOWING THE PROPOSED AREA OF THE WORKS AND THE WIDER SURROUNDING AREA (SOURCE: LIS, 2018)
